FLOOR

Improvement of misplaced holes/cutouts

Nr.
B12-110

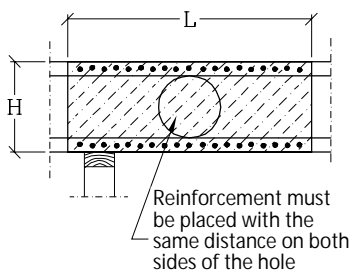
Holes should not be placed over or under a bearing wall.

Holes should not be placed closer to support than the beam height. Information regarding the reduction of shear capacity caused by a hole can be found in ETA 12/0018.

Circular holes must always be circular, else they should be evaluated according to the rules for holes in ETA 12/0018.

No holes or cutouts are allowed in the flanges.

Reinforcement of misplaced hole in the web must be done on both sides of the beam with moisture resistant particleboard, plywood or OSB, with a minimum thickness of 18 mm. Length of reinforcement and number of nails can be seen in the table to the right. The nails must have a minimum diameter of 2,5 mm and a length of 60 mm. Shorter nails can be used provided that they penetrate at least 35 mm into the flange. The distance between nails must be 30 mm.
